HEADQUARTERS
20TH ENGINEER BATTALION (COMBAT)
APO San Francisco 96318

SUBJECT: Operational Report-Lessons Learned (RCS CSFOR-65), for Quarterly
Period Ending 30 April 1967

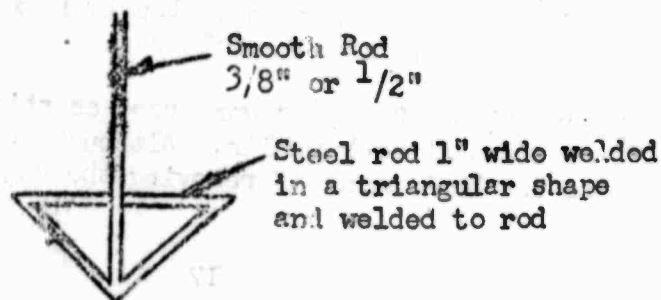
Discussion: Mixing the nonskid compound is a time consuming task and utilizes many personnel.

Observation: A paint mixer was fabricated to use with the heavy duty electric drills in the pioneer electrical tool sets. This method was quicker and required fewer people. The design is as follows:
